Composite Materials in Aircraft Mishaps Involving Fire: A Literature Review

Mark T. Wright, Ariam C. Luers,
Robert L. Darwin, and
Joseph L. Scheffey
Hughes Associates, Inc., Baltimore, Maryland

Howard L. Bowman, Ross A. Davidson,
and Eric J. Gogley
Engineering Sciences Division
Research Department
Naval Air Warfare Center Weapons Division, China Lake, California

NAWCWD Technical Publication 8552

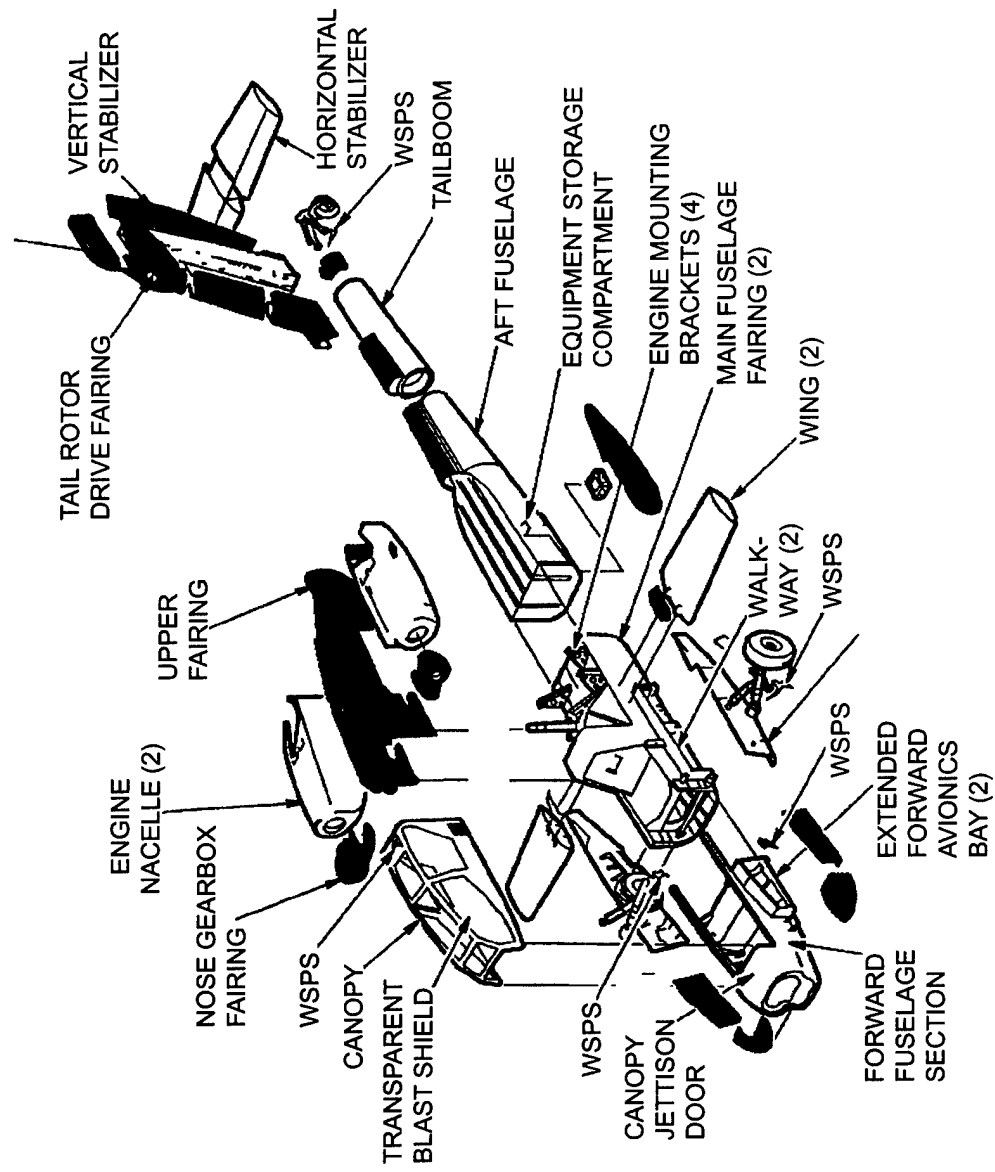
AH-64D**AIRFRAME MATERIALS****1. AIRFRAME MATERIALS**

- a. Main Rotor Blades (not pictured) are constructed of stainless steel, aluminum, fiberglass, and nomex honeycomb.
- b. Cockpit flooring (not pictured) is constructed of Boron armor.
- c. Crew seats (not pictured) are constructed of Kevlar/Boron carbide and nylon.
- d. Tail Rotor hub forks (not pictured) are constructed of Titanium.
- e. Both aircraft engines (T700-GE-701-C) are constructed with Titanium/Carbon/Nickel Graphite.
- f. Battery (not pictured), located on the right side is a Fiber Nickel-Cadmium battery.

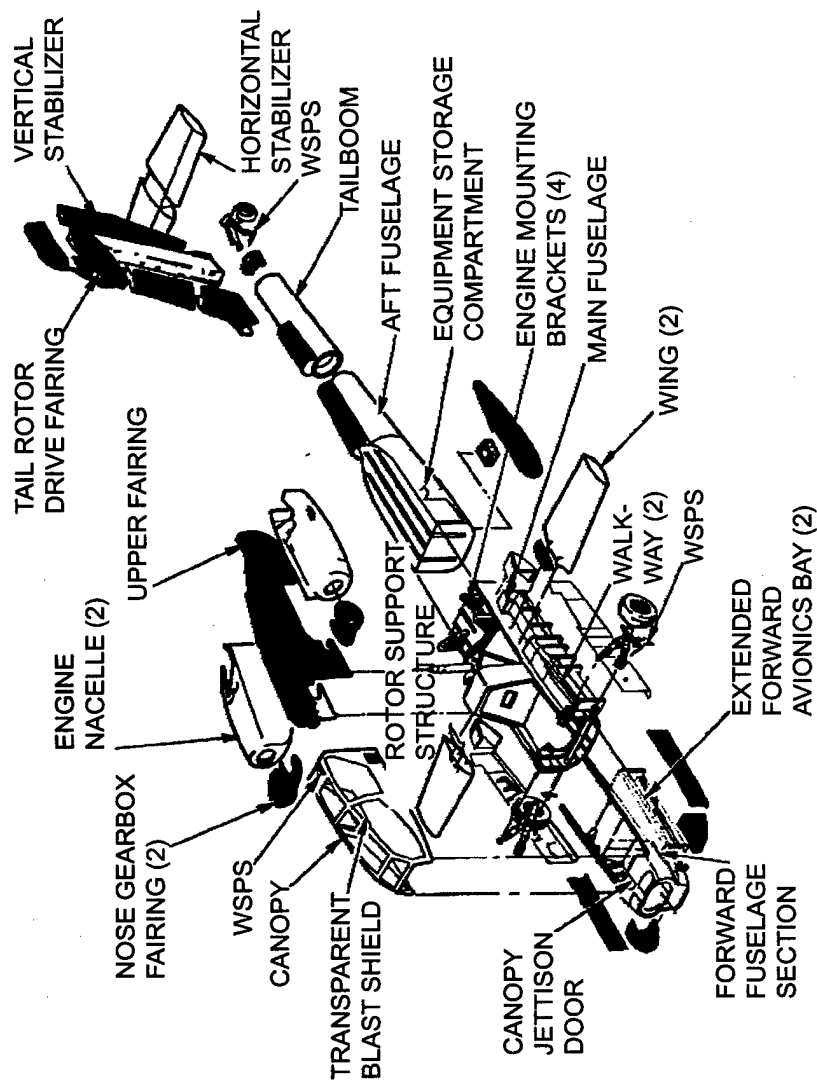
- a. Aluminum
- b. Carbon/Epoxy
- c. Carbon/Kevlar/Epoxy
- d. Glass Fiber Reinforced Plastic
- e. Kevlar/Foam Core
- f. Kevlar/Nomex
- g. Carbon/Nomex

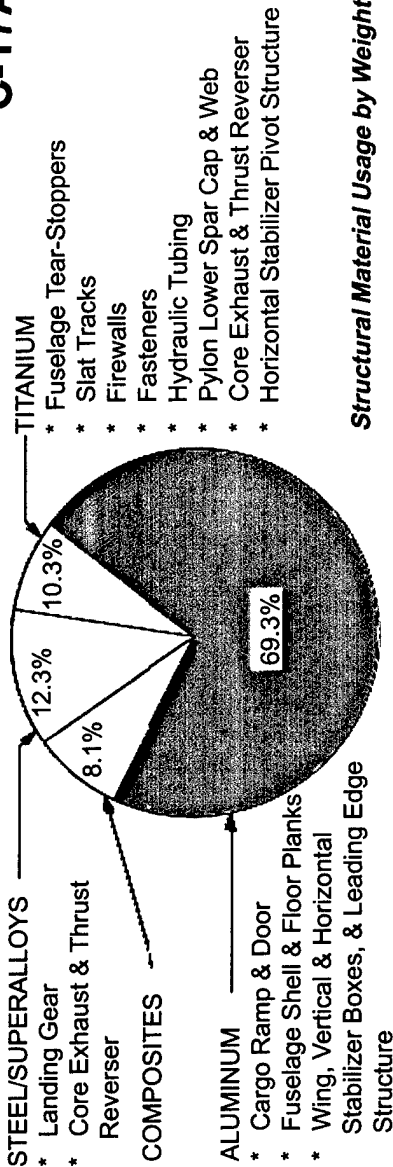
C-17A

The fuselage and wing are constructed primarily of aluminum alloy material. However, aluminum-lithium, titanium, steel, and composite materials are used wherever there are cost-effective advantages in weight, fatigue life, or corrosion resistance.

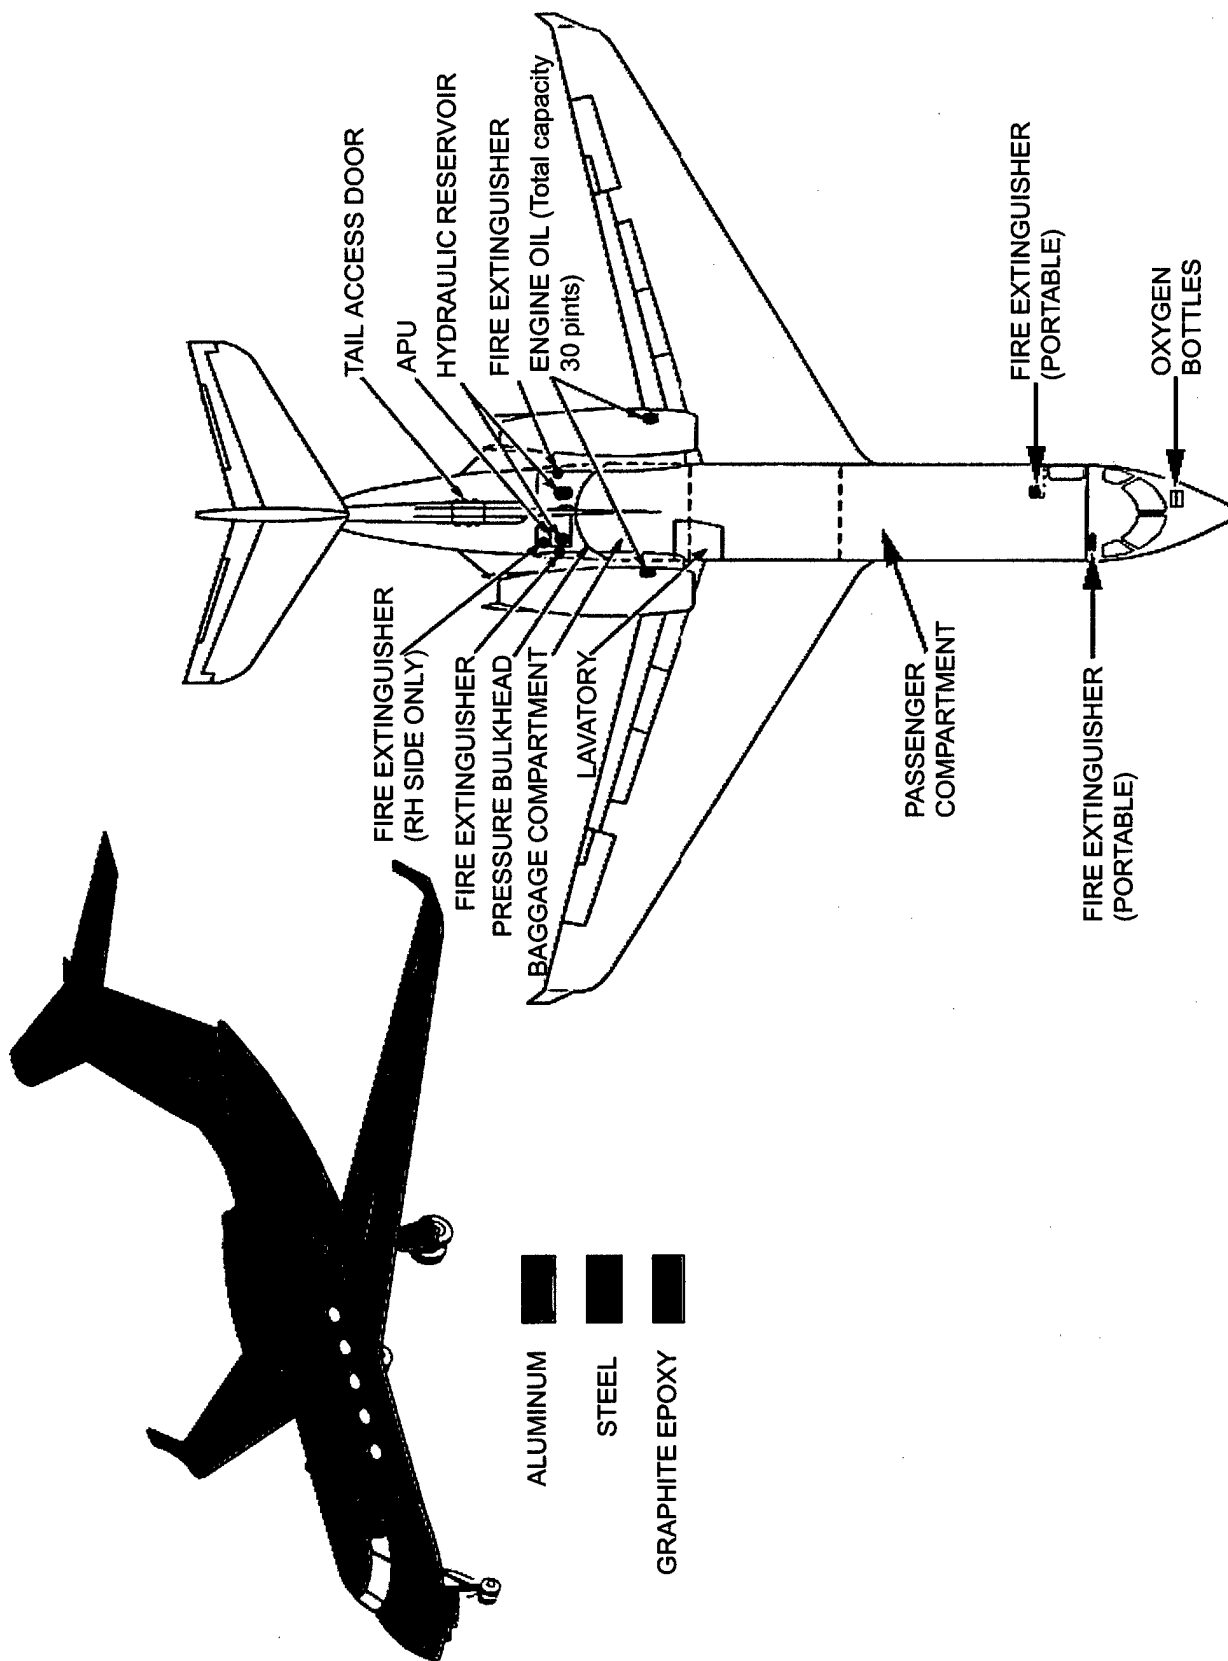
C-32A**AIRFRAME MATERIALS
STRUCTURE AND COMPOSITES****NOTE:**

The airframe materials for the C-32A are titanium, titanium alloy, carbon fibre, carbon-reinforced aramid-fiberglass, aramid and carbon epoxy preimpregnated raw material.

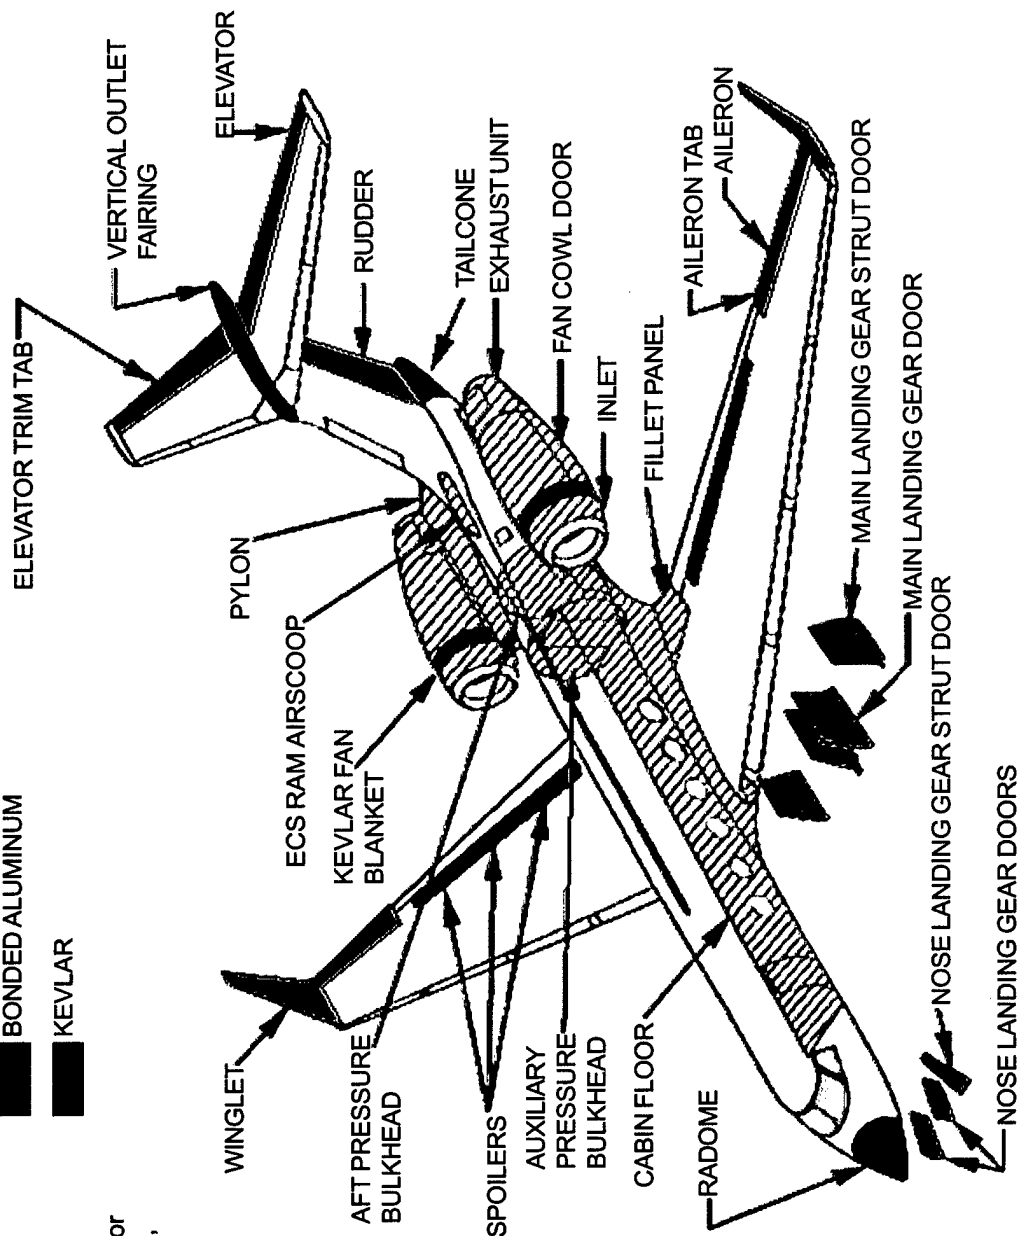
C-38A**COMPOSITE MATERIALS**

Composite materials are used extensively on this aircraft (Gulfstream V) to save weight and increase strength. Composite materials include metallic and non-metallic structures for bulkheads, doors, flight controls, floor panels, fairings, nacelles, panels, pylons, radome, tailcone, and winglets.

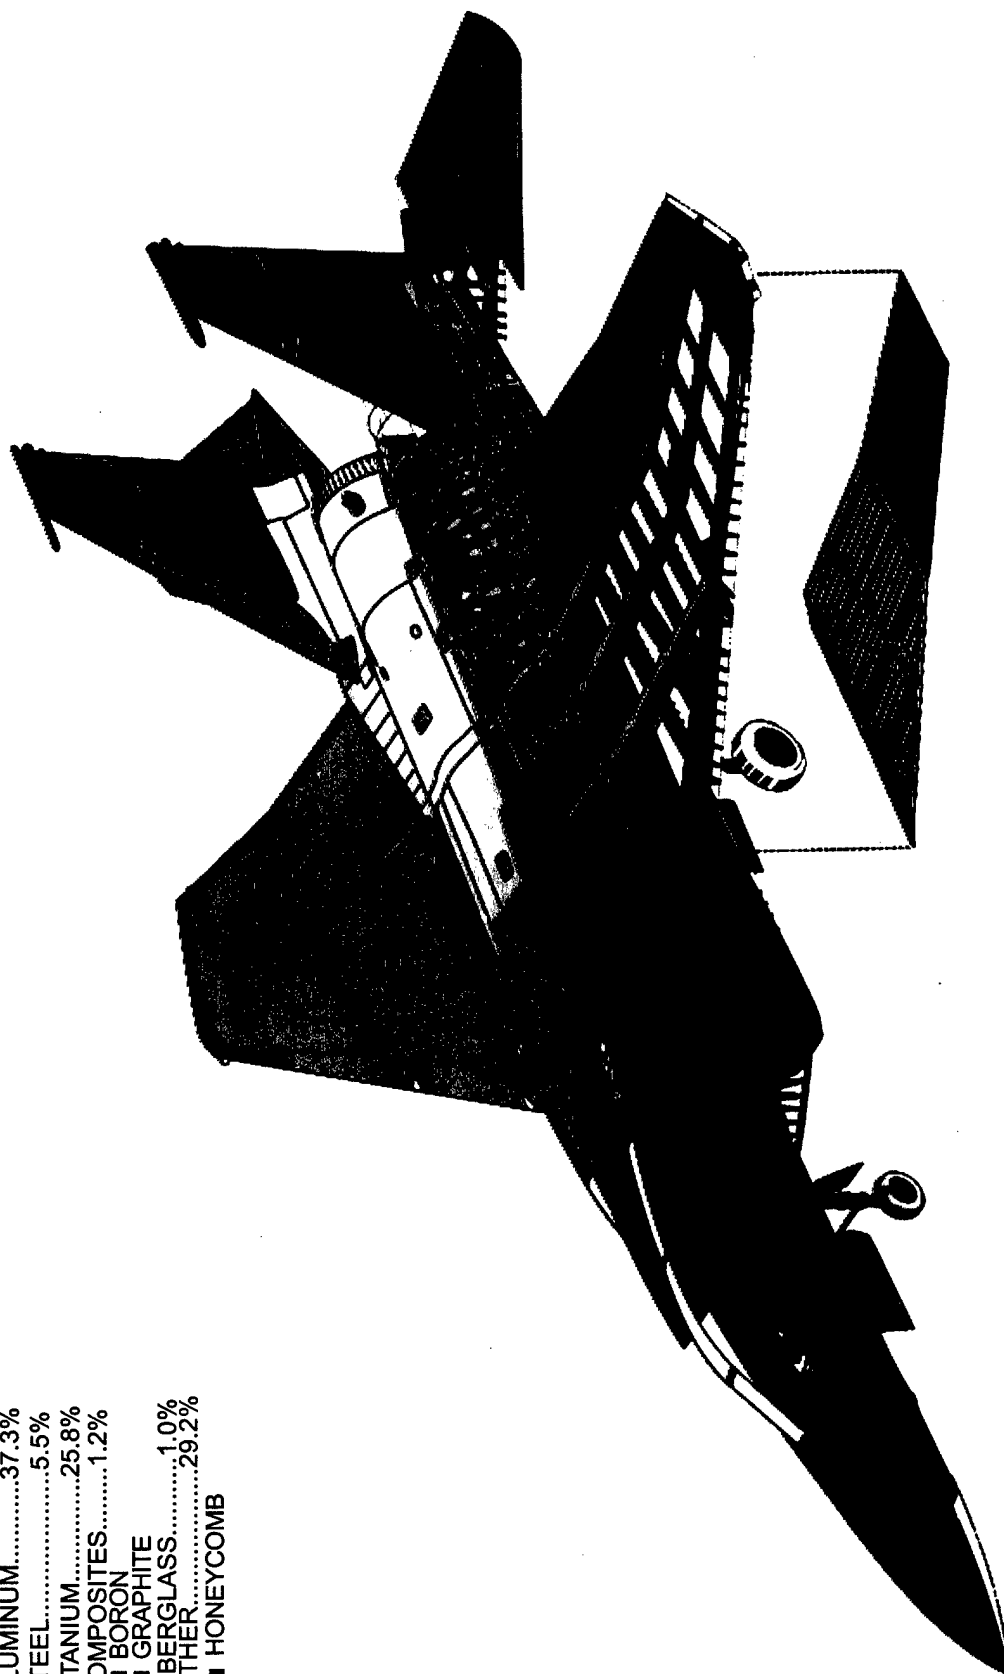
F-15

■	ALUMINUM.....	37.3%
□	STEEL.....	5.5%
■	TITANIUM.....	25.8%
■	COMPOSITES.....	1.2%
■	BORON.....	
■	GRAPHITE.....	
■	FIBERGLASS.....	1.0%
■	OTHER.....	29.2%
■	HONEYCOMB.....

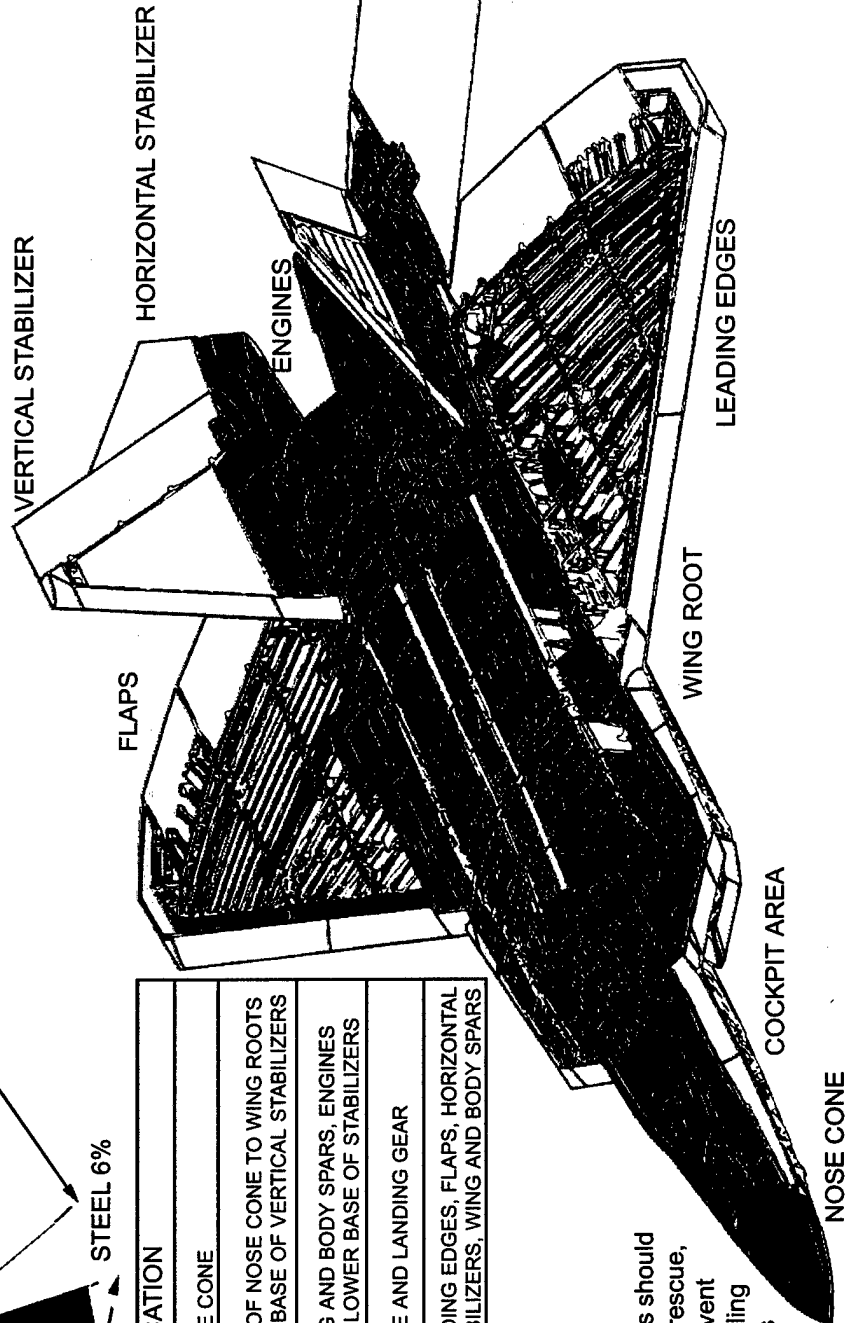
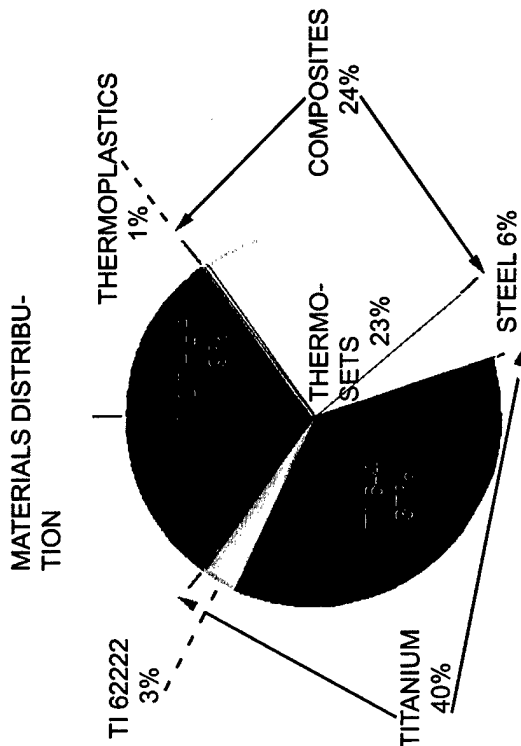
F-22A

Organic composite structural laminates are made up of stacks of oriented thin lamina that consolidated under heat and pressure. Each lamina consists of a layer of high-strength, high-modulus, low-density reinforcing fibers embedded in a resin matrix. Fibers typically are materials such as carbon, boron, Kevlar 49, or fiberglass. The matrix can be either a thermosetting material such as epoxy, bismaleimide, or polyimide, or a thermoplastic material. If the matrix is thermosetting, a solid material is formed that cannot be reprocessed. Thermoplastic materials, however, can be reshaped by reheating and reforming.

MATERIALS LOCATION	
OTHER	NOSE CONE
ALUMINUM	AFT OF NOSE CONE TO WING ROOTS AND BASE OF VERTICAL STABILIZERS
TI 6222 (TITANIUM) TI 6-4 (TITANIUM)	WING AND BODY SPARS, ENGINES AND LOWER BASE OF STABILIZERS
STEEL	NOSE AND LANDING GEAR
THERMOPLASTICS (COMPOSITES)& THERMOSETS (COMPOSITES)	LEADING EDGES, FLAPS, HORIZONTAL STABILIZERS, WING AND BODY SPARS

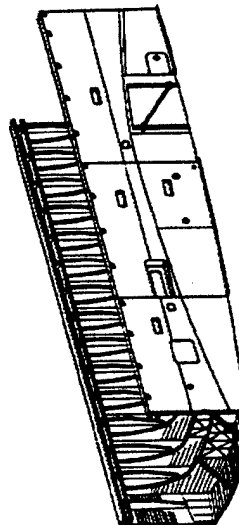
AFT FUSELAGE
- Integrally Machined Skin/
Stiffener Shell
- Titanium/Boron Epoxy
Thrust Structure

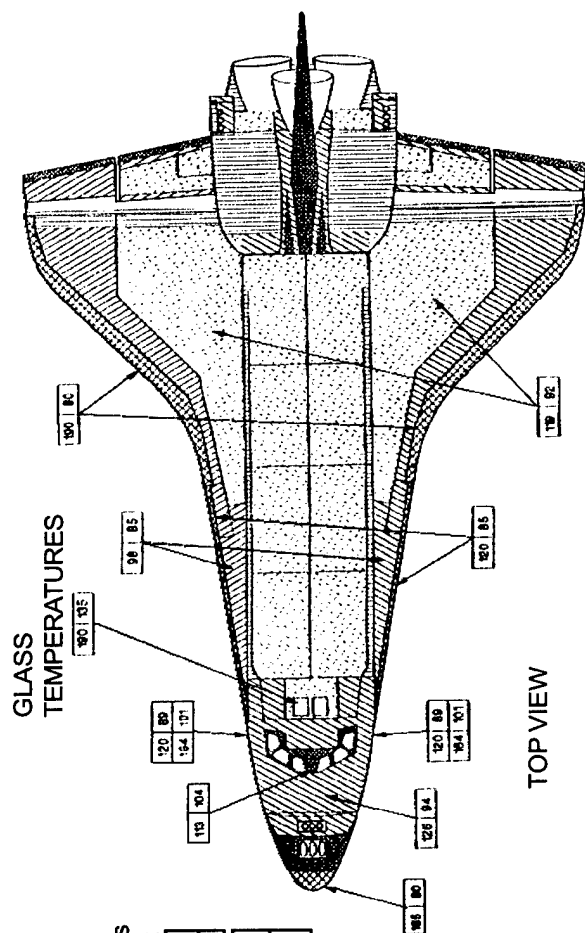
TOP VIEW

- Single-level boxes indicate TPS temperature only.
